SpinScope

Monitoring Bearing Health

Executive Summary

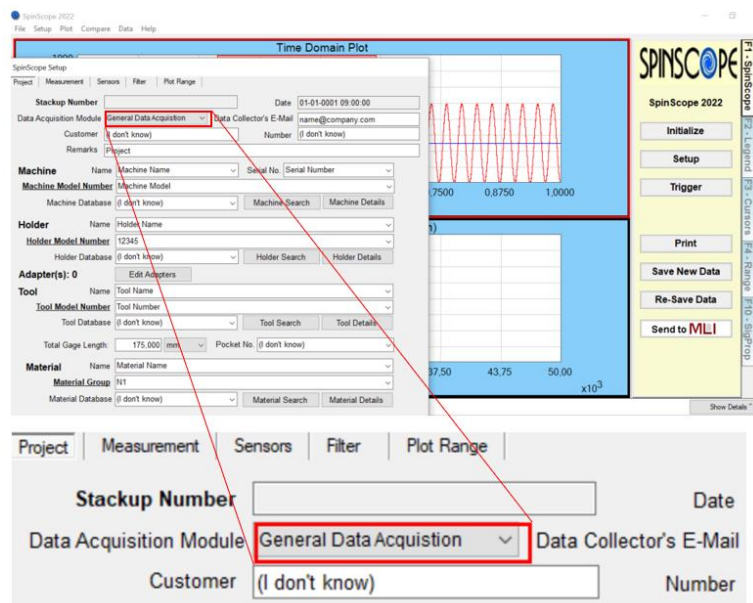
Figure 3: Setup window in the 64-bit SpinScope software. Licensing permitting, the data acquisition module could be changed to the more specific "Spindle Condition".

After thoroughly testing the software for both the 32- and 64-bit Tap Test laptops, it was determined that the functionality of the SpinScope software (Figure 3) is severely limited by the software license possessed by DAMRC. With the current licenses, the 64-bit version of SpinScope is completely unusable, while for the 32-bit version of SpinScope all of the specialized modules, including spindle condition, are unusable so that it is only possible to use the software in "general data acquisition mode". In general data acquisition, any transducer of choice is used with a data acquisition (DAQ) card to read measurement data into the PC in much the same way as is done for tap tests. The measured time-domain signal is provided by the software along with its frequency content. The software allows for four measurement channels to be used concurrently.

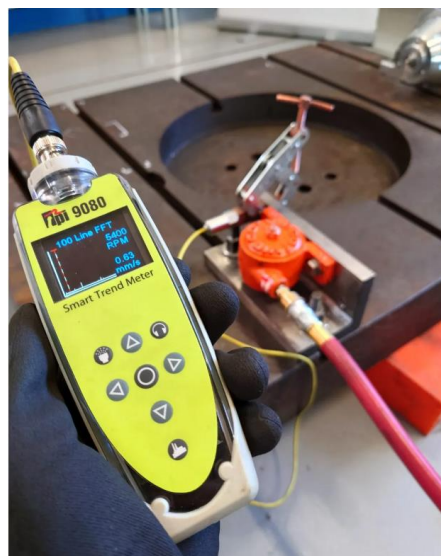
Figure 4: The SmartMeter from TPI Inc.

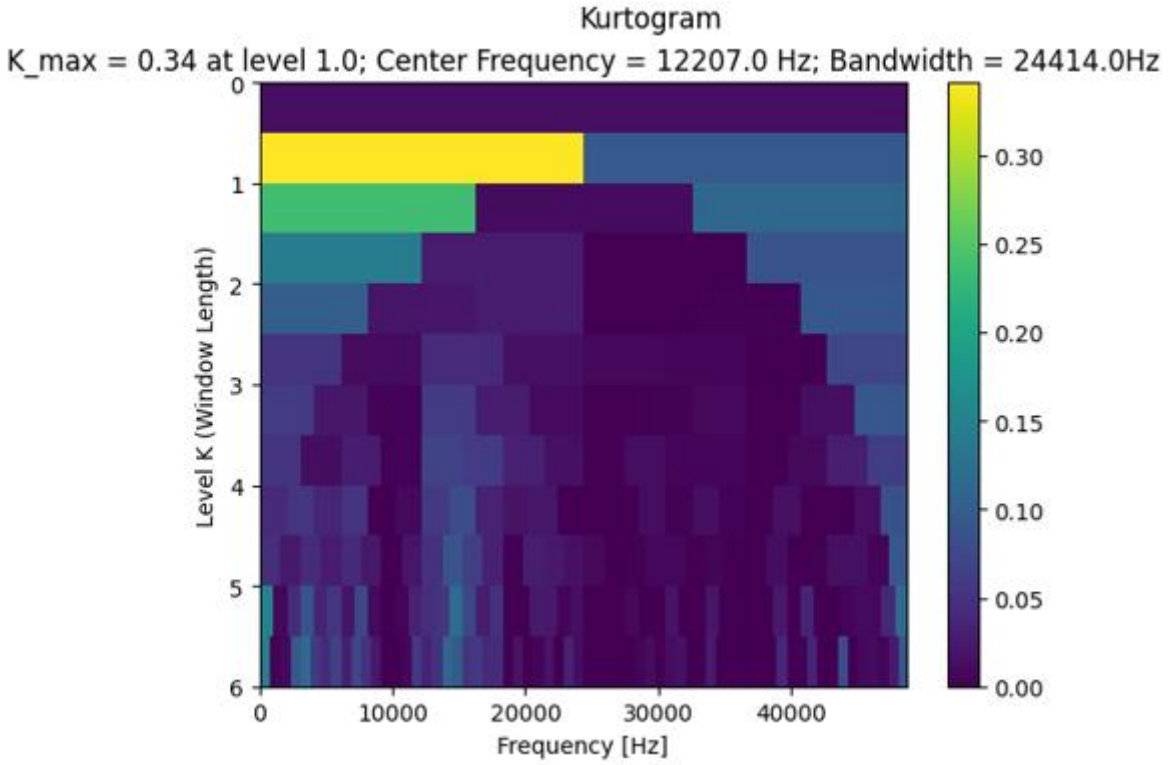
Figure 18: Kurtogram for the simulated healthy bearing

The resulting Kurtogram is presented in Figure 18. The Kurtogram shows that the frequency spectrum of the baseline data exhibits a spectral kurtosis that is maximum in a frequency band centred at 12207 Hz with a bandwidth of 24414 Hz. This information is then used to define the window length and central frequency of the bandpass filter used in envelope analysis. The result of the envelope analysis is shown in Figure 19. The figure indicates that there are no noteworthy frequency components in the baseline data after envelope analysis, and that this is true for both the analysis implemented in python as well as in the MATLAB example [25]. In this case, all of the frequency spectra presented in the figure are indistinguishable from that of a noisy signal.

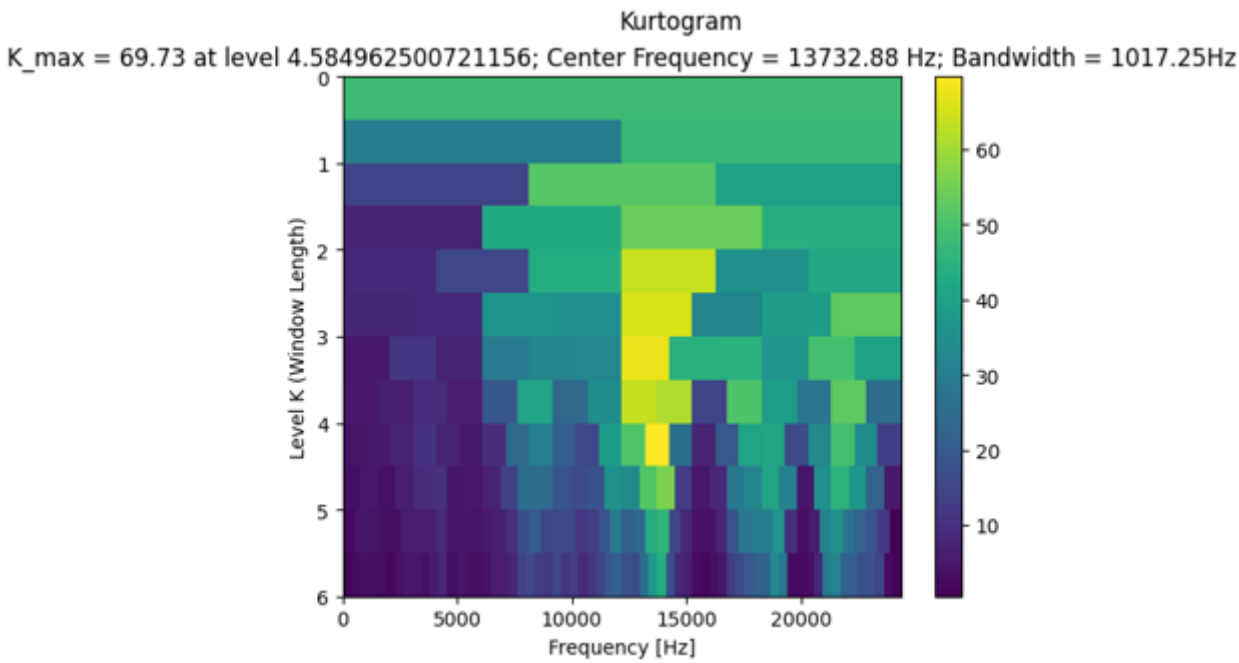
Figure 20: Kurtogram for the simulated inner race fault.

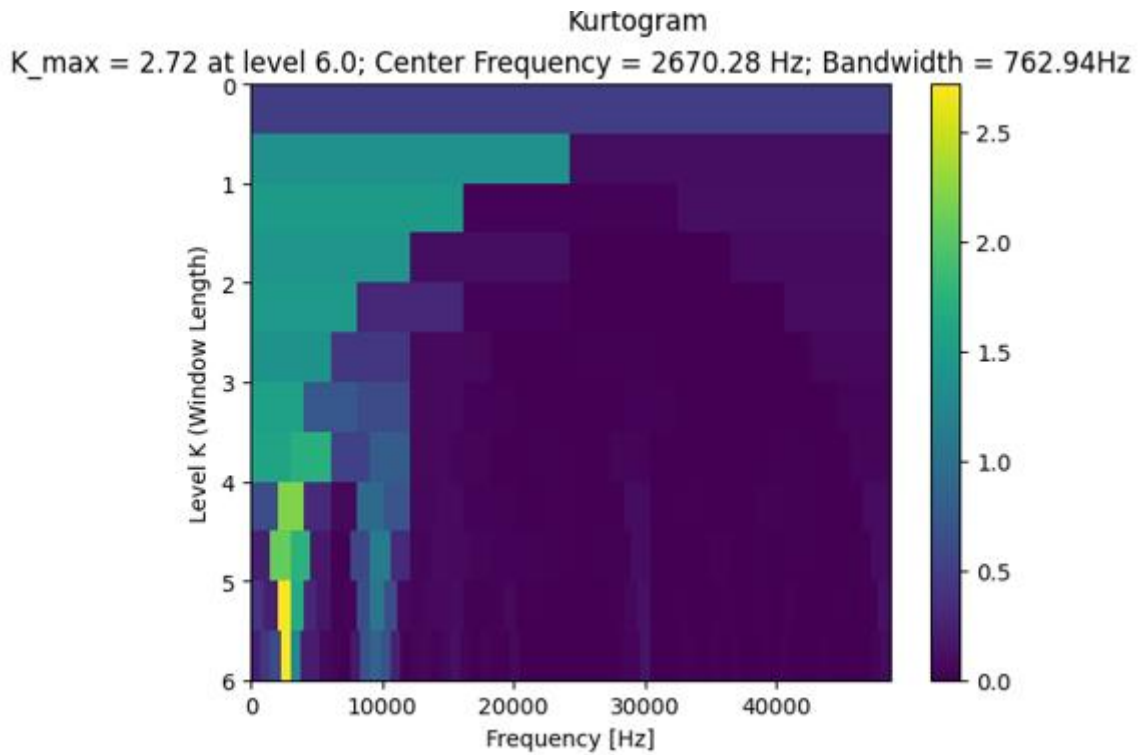
Figure 22: Kurtogram for the simulated outer race fault

The resulting kurtogram is presented in Figure 22. The kurtogram shows that the frequency spectrum of the outer race fault data exhibits a spectral kurtosis that is maximum in a frequency band centred at 2670 Hz with a bandwidth of 763 Hz. This information is likewise used to define the window length and central frequency of the bandpass filter used in envelope analysis. The result of the envelope analysis is shown in Figure 23. The figure indicates that the distinct frequency components corresponding to the fault impact frequency in the frequency spectrum are present, and that comparable results are obtained in the MATLAB example. When envelope analysis is not used, however, the resulting frequency spectrum becomes indistinguishable from a noisy signal, similar to the 'raw' spectrum obtained in the first case study for healthy bearing. Then in this case an incorrect diagnosis of the bearing (in this case a false negative) can be made if envelope analysis is not implemented. The same conclusions regarding the resulting frequencies and their amplitudes can be made as was done for the second case study (for the inner race fault).

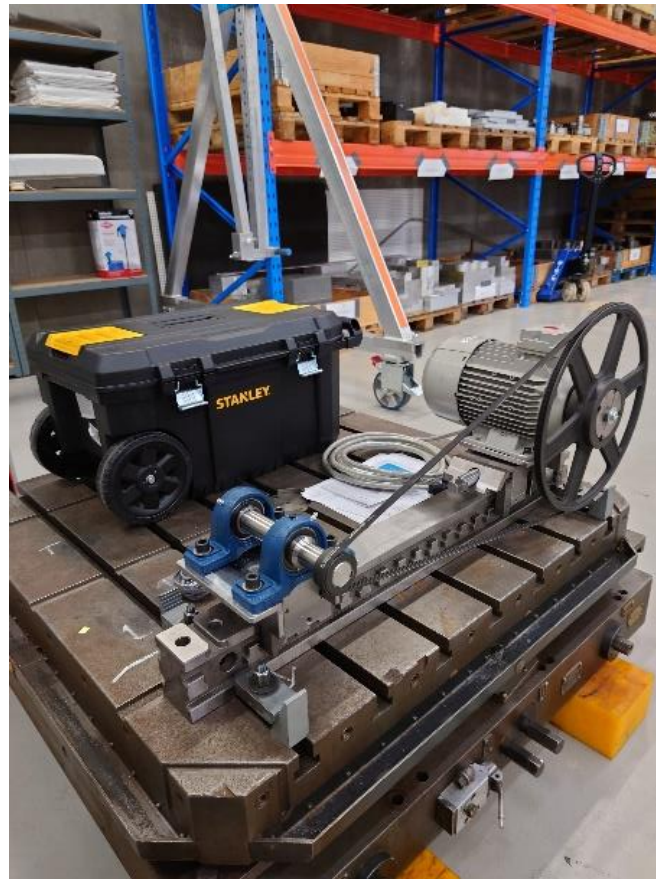
Figure 24: The test rig used at DAMRC to verify the implemented envelope analysis

The spectral kurtosis and envelope analysis tested in the numerical case studies of the previous section was further validated with recorded vibration signals obtained from tests using the custom test rig at DAMRC shown in Figure 24. The tests consisted of placing the ‘large’ accelerometer (PCB model 352068) from the 32-bit MetalMax equipment on the test bearing and recording the resulting vibration signals while the shaft was running at a prescribed speed controlled by the variable speed drive. Six recordings of 30 seconds are obtained each for the healthy bearing and for a damaged bearing. The shaft speed is regulated to operate at approximately 1100 RPM, with some degree of speed fluctuation expected, and measured independently of the control system depicted in Figure 13 using the tachometer.

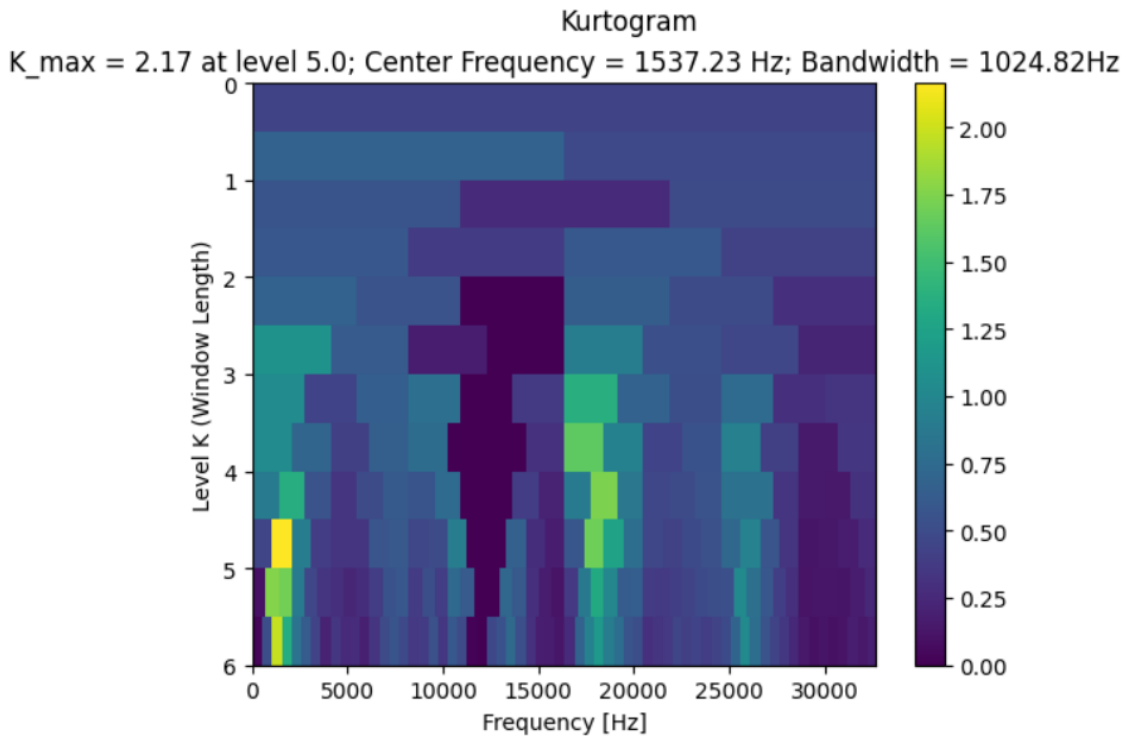
Figure 26: Kurtogram generated during trial 4 for the healthy bearing

The kurtogram for the healthy and damaged bearing are shown in Figure 26 and Figure 27, respectively. From the results obtained in section 9.2 and as reported in the literature, it is generally expected that when a bearing fault is present spectral kurtosis is maximal in a narrow frequency band centred at a high frequency associated with the dynamics of the machine structure that amplifies the impact between the bearing fault and the rolling elements. These results are therefore expected to be present in the kurtograms shown in the figures below.

The kurtogram for the healthy and damaged bearing are shown in Figure 26 and Figure 27, respectively. Comparing the results in the two figures, it is observed that the kurtogram for both bearings present a maximal spectral kurtosis in a similarly sized frequency bandwidth of approximately 1024 Hz. However, the central frequency of this frequency band is much higher for the damaged bearing than it is for the healthy bearing (24,063 Hz for the damaged bearing compared to 1,537 Hz for the healthy bearing). Similarly, the maximum spectral kurtosis for the healthy and damaged bearing are reported as 2.17 and 20.73, respectively. Therefore, the resulting maximum spectral kurtosis and central frequency for the healthy and damaged bearing presented in Figure 26 and Figure 27 are consistent with expected results, while the bandwidth for the healthy bearing was expected to be wider than that for the damaged bearing.

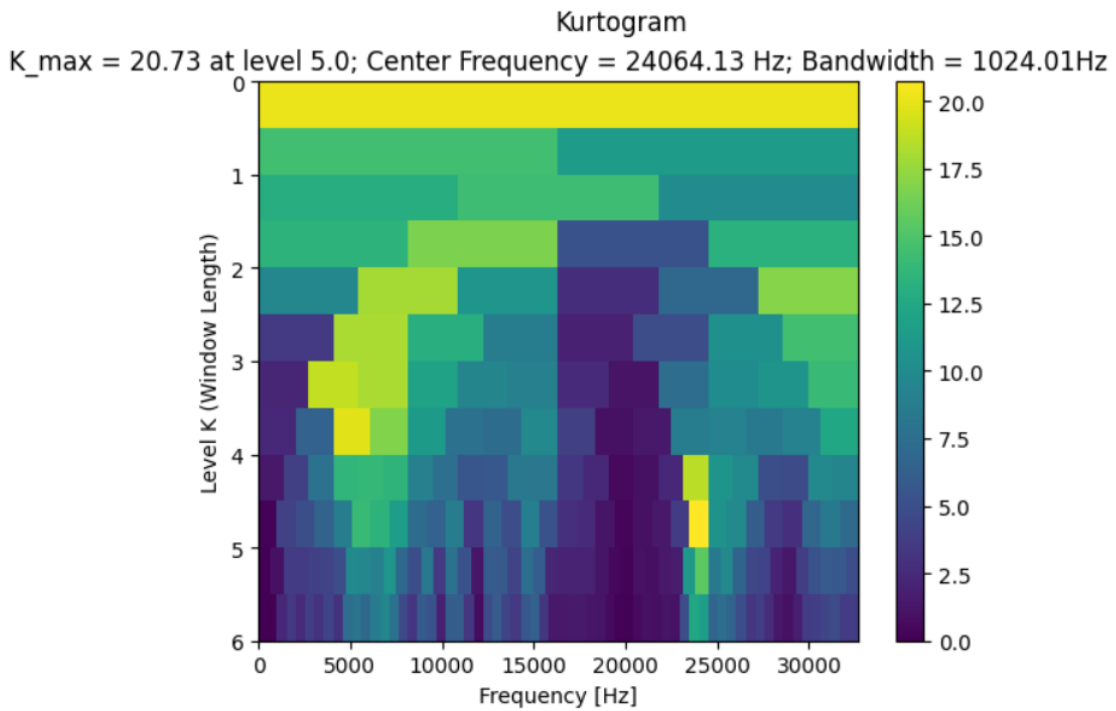
Figure 27: Kurtogram generated during trial 4 for the damaged bearing

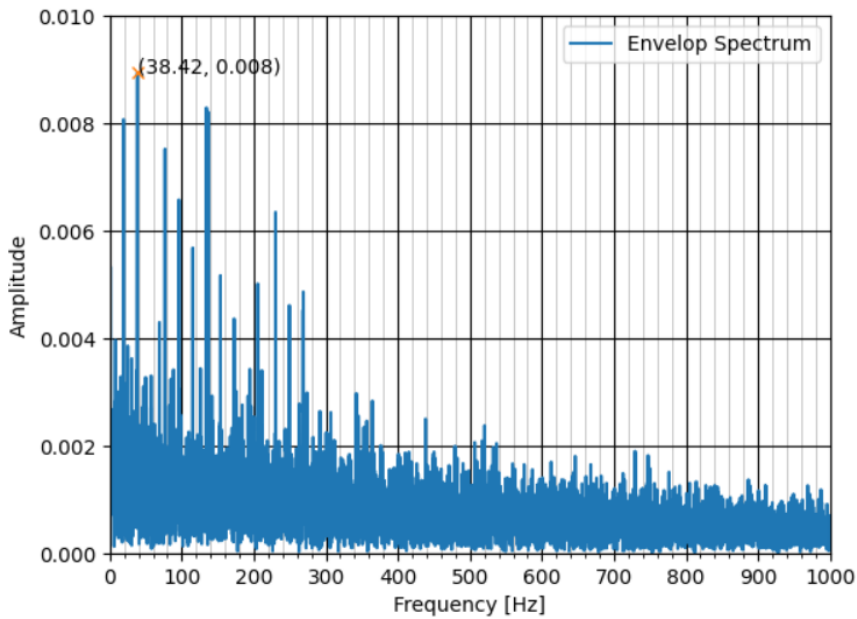
Figure 28: Envelope spectrum for the healthy bearing

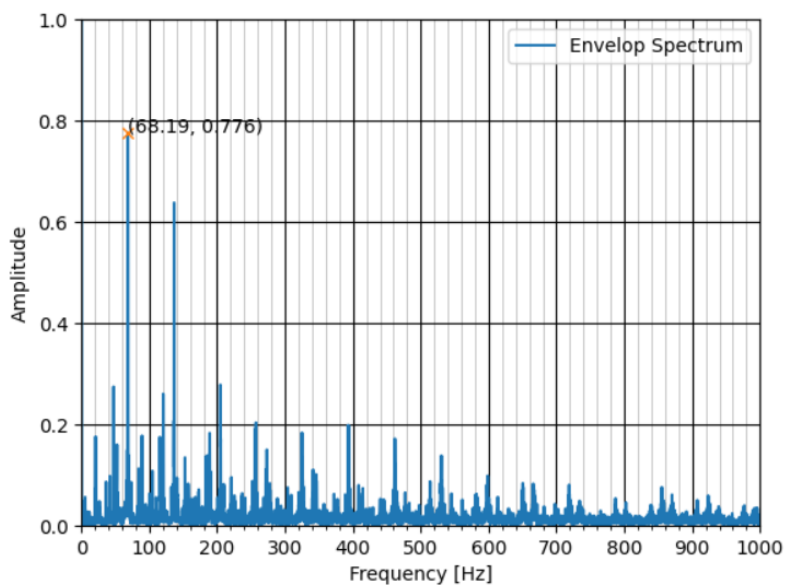
Figure 29: Envelope spectrum for the damaged bearing

Considering the results for the damaged bearing, the relative error between the experimental and theoretical impact frequency is calculated to be on the order of 2%, where the experimental impact frequency is taken as the fundamental frequency detected in the envelope spectrum and the theoretical frequency is calculated according to equation 1 in section 7.2. The resulting relative error is largely consistent across all trials as shown in Table 3.

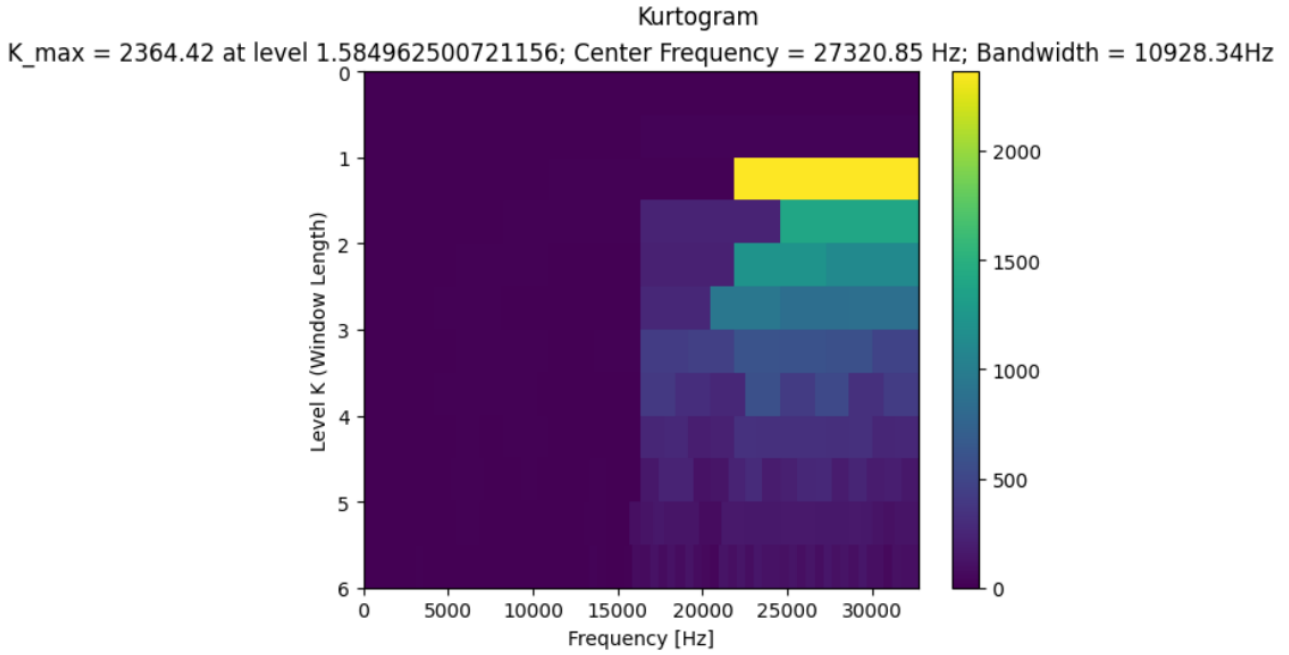
Figure 33: Kurtogram generated during trial 3 for the damaged bearing.

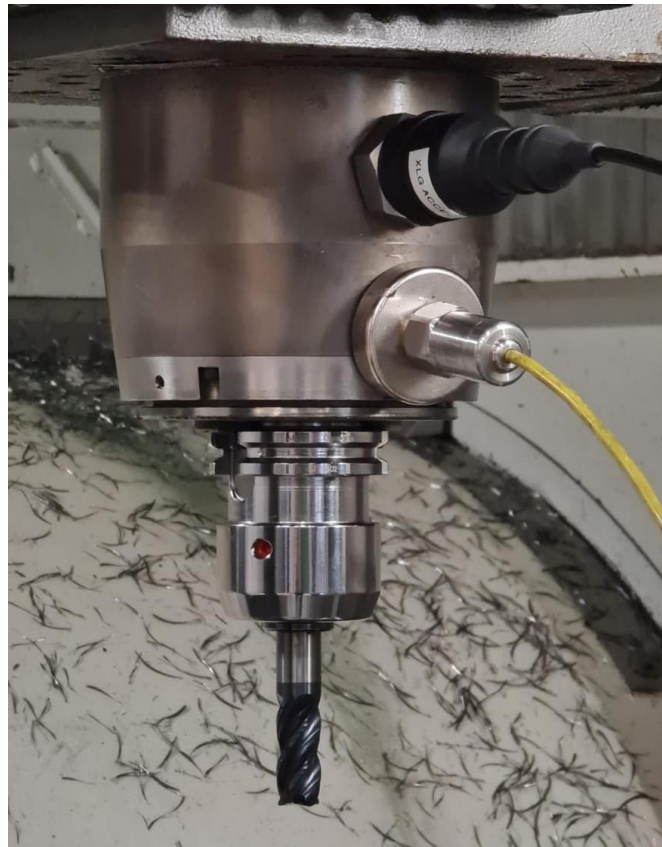
Figure 37: Accelerometer placement on the DMU.

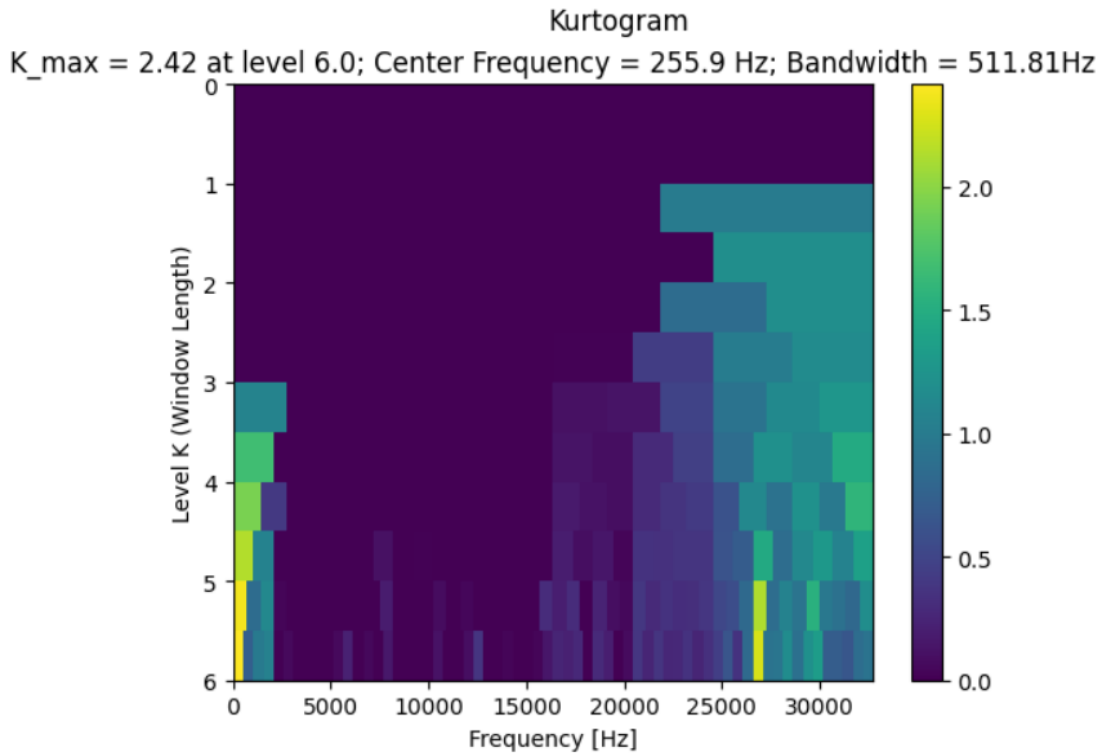
Figure 46: Kurtogram generated during trial 2 at 10,000RPM
